Medial Displacement of Cochlear Implant Magnet Following Trauma

Mary Lauren Worthen, MD¹; Arun Gadre, MD, FACS¹;

¹Department of Otolaryngology-HNS and Communicative Disorders, University of Louisville School of Medicine

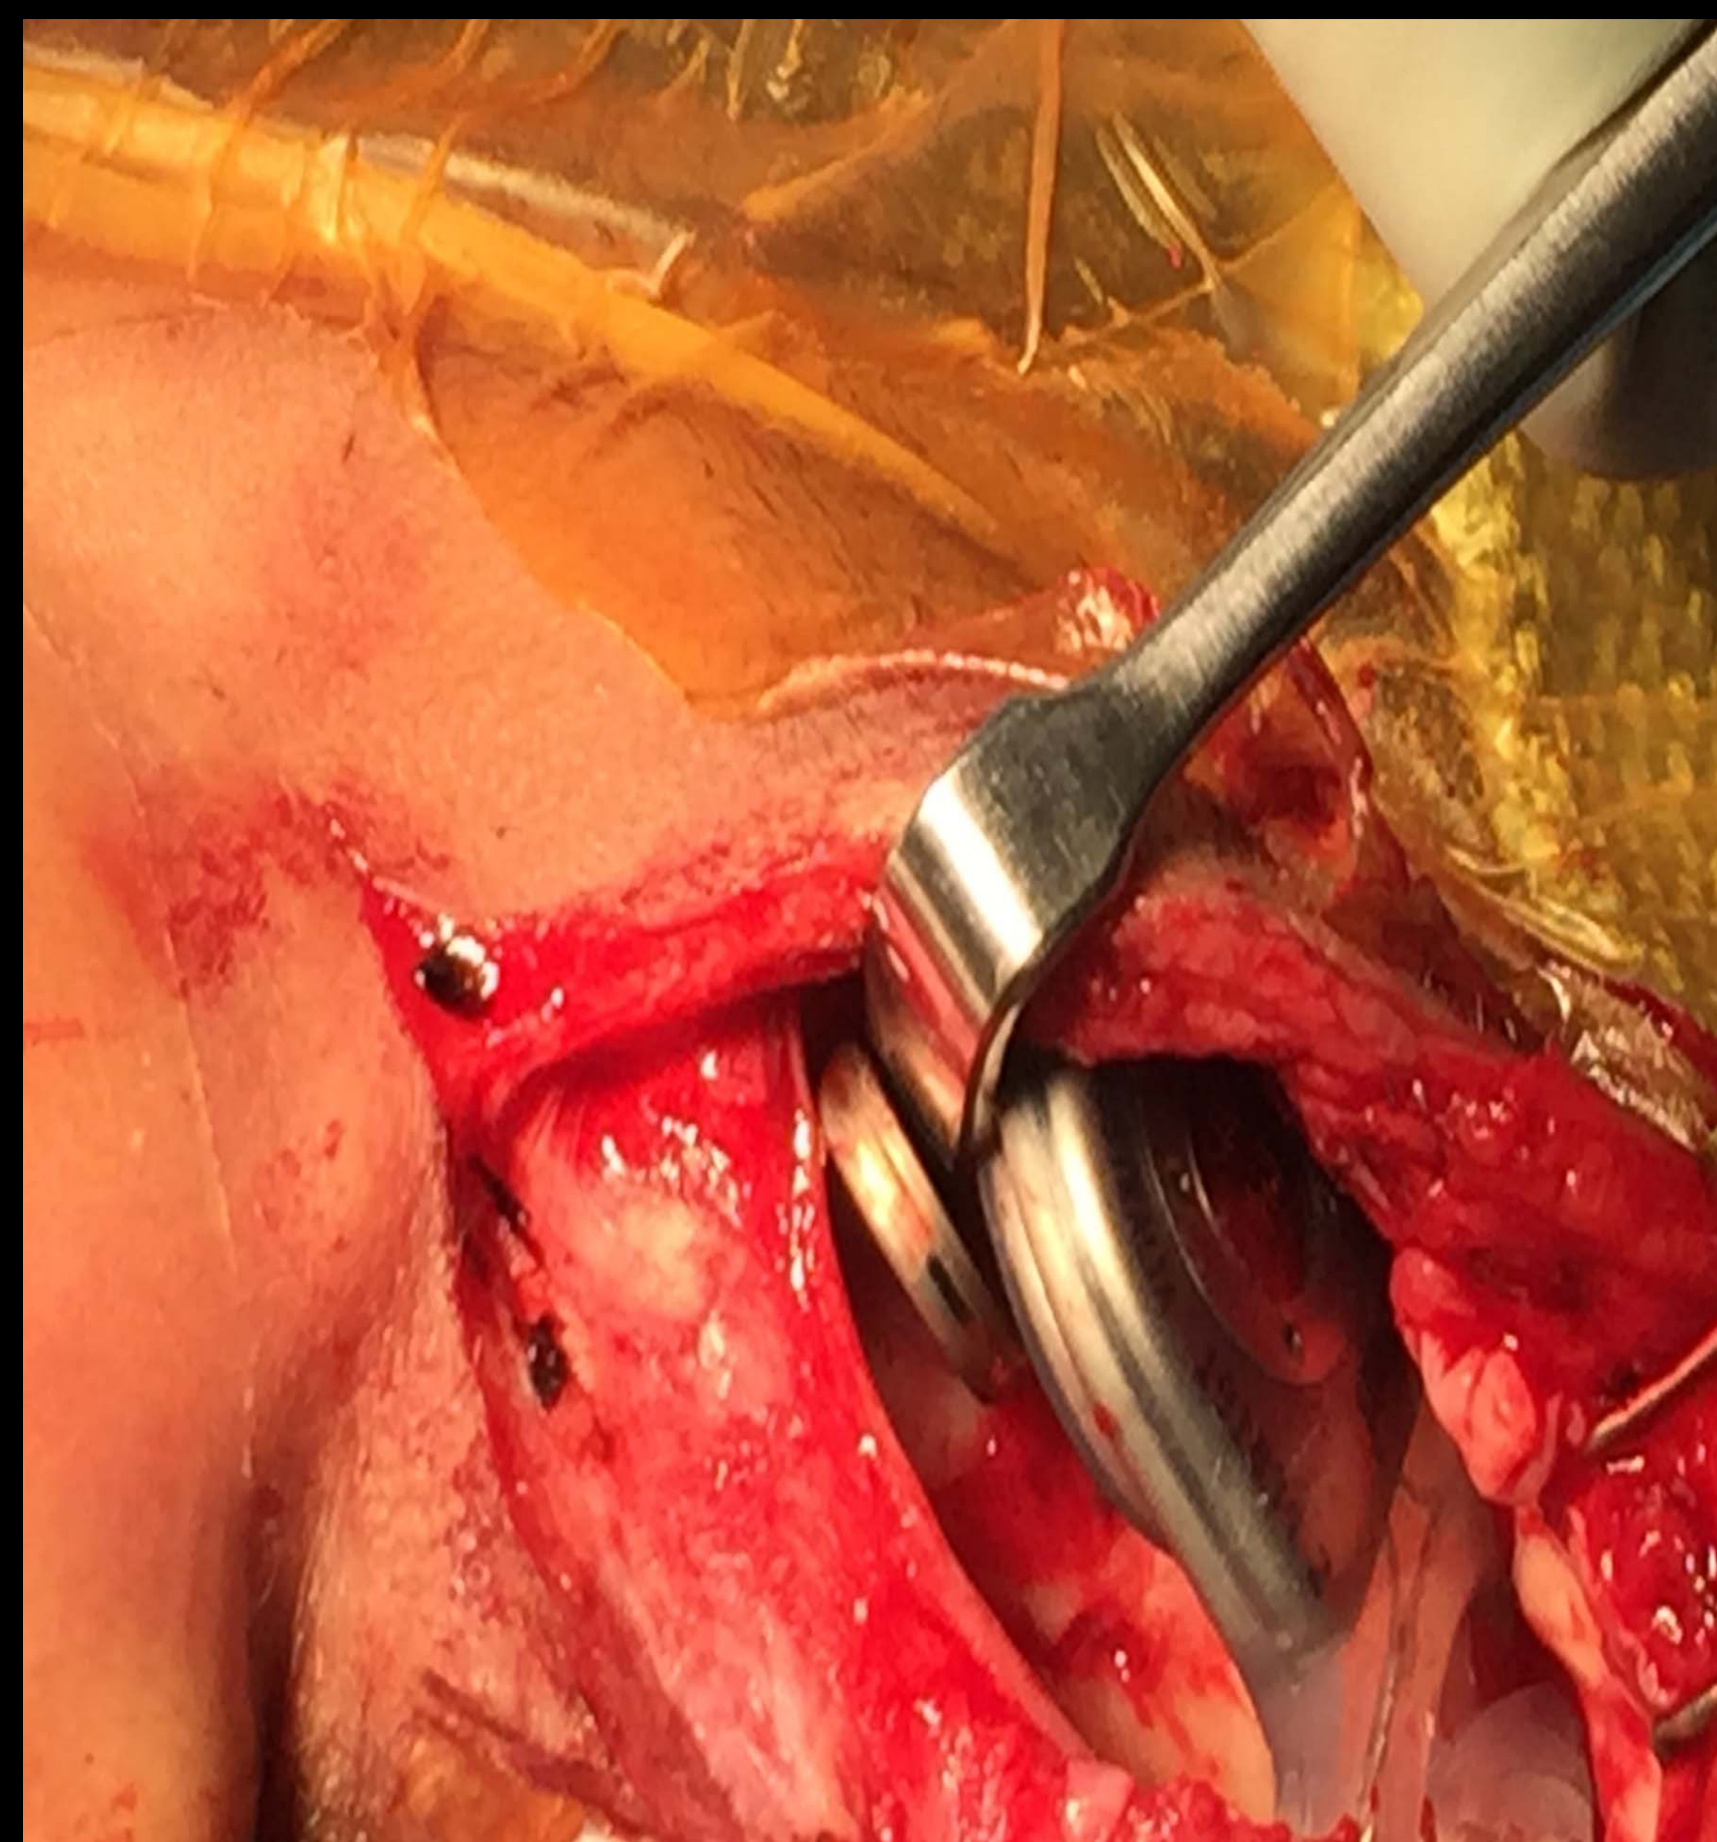
Figure 2: Intraoperative image of cochlear implant magnet displaced medially
